# The Seven Year Leap

Updating a product from Linux 2.6 to 4.15,  
a real-world project case study

ELC-E October 2018, Edinburgh UK

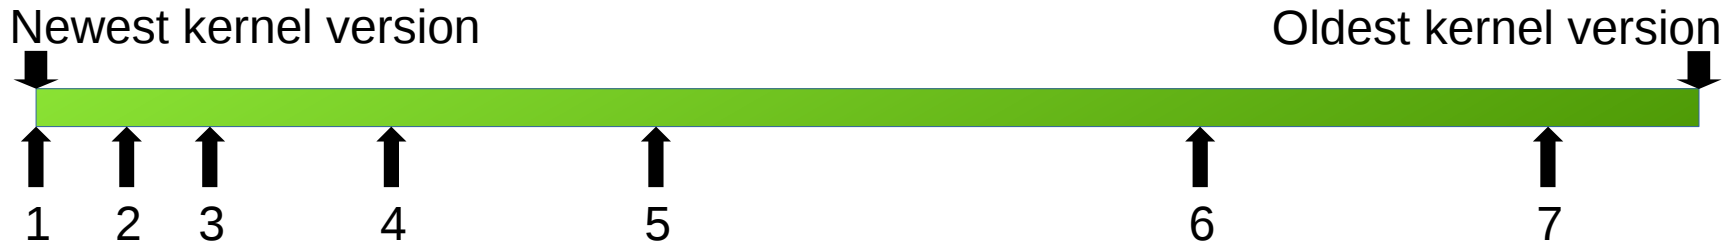
1: kernel maintainer

2: semiconductor/IP vendor (Initial support may go into their own repository first)

3: Recently started product/device development

4: bigger Linux distributions, (Extending to right for LTS maintenance)

5: BSP or dev kit vendor for class of devices (E.G. set top boxes)

6: Ongoing product development/maintenance (Or new one with bad BSP)

7: Legacy / heavily regulated / safety critical device maintenance
